# The Pioneer Spin Anomaly as an Observation Artefact

## Abstract

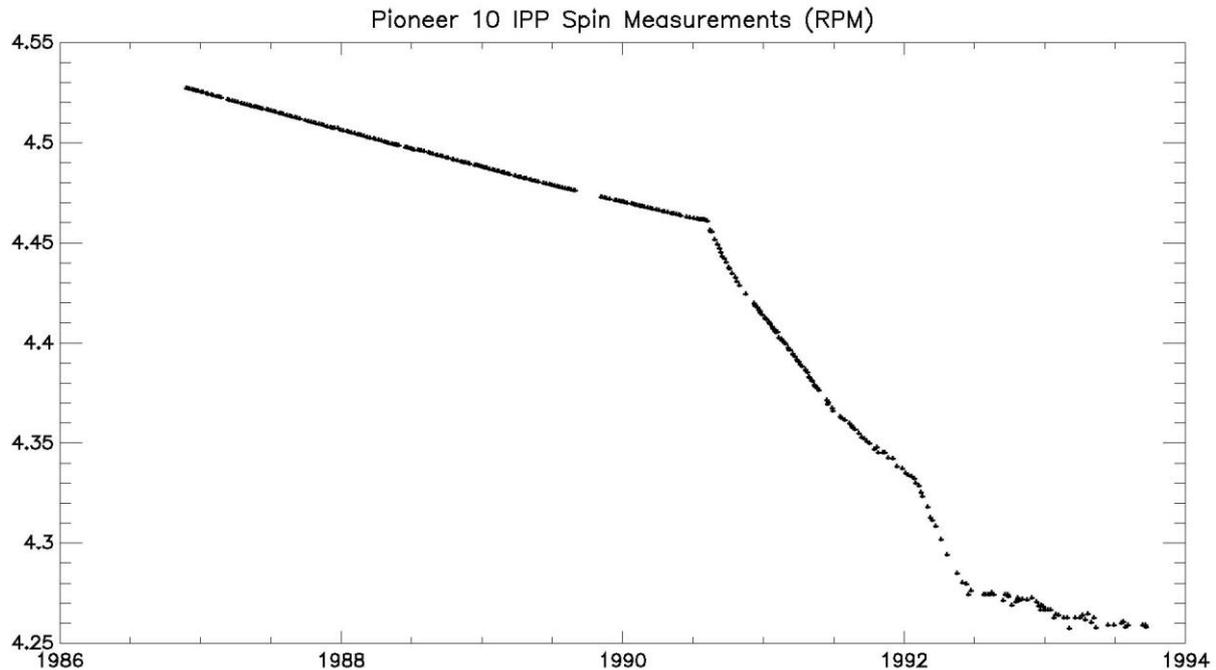
Figure 1. Pioneer 10 IPP Spin Measurements

Figure 1 displays the marked Pioneer 10 spin anomaly. The data used to produce this figure has been provided from the Anderson *et al.* team, through Slava Turyshev and Viktor Toth, and recently made available to the public via the NASA Goddard Space Flight Center, Space Physics Data Facility (SPDF). All values displayed in Figure 1 are derived from IPP measurements. A steady 'linear' decrease in the spin rate is evident prior to 1990. This decrease rate is consistent with earlier spin measurements using on-board sensors. We can easily imagine that unbalanced thermal radiation might explain this long-term linear decline. As reported in [1] (and clarified in [2] with correction of an editing error in [1] where spin period was presented as RPM), Pioneer 11 experiences a similar long-term decrease in spin rate between manoeuvres. (In the Pioneer 11 case it appears that there are additional significant spin contributions from gas leaks or thruster alignment/imbances at manoeuvre times.)

Around the early part of 1990 there is a noticeable decrease in the rate of Pioneer 10 IPP-determined spin decline, as shown in Figure 1. In mid-1990 there is a large step change in the rate of spin decline, marking the start of the major spin anomaly period. During the interval from mid-1990 to mid-1992, there are minor fluctuations evident in the slope of the plot. From mid-1992 the spin rate decline reverts to approximately the same slope prior to 1990, albeit with significantly increased "measurement noise". All these observations form part of the Pioneer 10 spin anomaly, and are extremely challenging to rationalise in terms of 'known'

We note that Anderson *et al.*[1] include, in their Figure 11, data for later spin determinations made during conscan manoeuvres. With radioactive decay of the Plutonium heat source and associated thermocouple decline, insufficient power was available late in the extended tracking mission to operate the IPP. The conscan spin determinations are included in the SPDF data mentioned above, and appear to align with the rough trend of the IPP spin values shown in the latter part of Figure 1 above.

Private communication with Slava Turyshev has indicated that there has been no independent verification of the IPP spin determinations. The data as presented in Figure 1 above, appears to have been treated as a given from the Anderson *et al.* team. This is understandable while a primary focus remains the Pioneer Anomaly, but seems insufficient for proper consideration of the Spin Anomaly. As the IPP data stream looks to be present within the MDR record, the missing piece of the puzzle to be able to independently verify the IPP results is detailed design information in relation to the IPP device, including detail of associated operational modes. It is understood that this information is readily available within NASA documents, such as “PC-202”, and it is expected that these documents can be released publicly in short order.
